**USFS-ABANDONED MINE LAND INVENTORY PROJECT
FINAL SUMMARY REPORT**

PIKE/SAN ISABEL NATIONAL FOREST

SOUTH PARK RANGER DISTRICT

Colorado Geological Survey

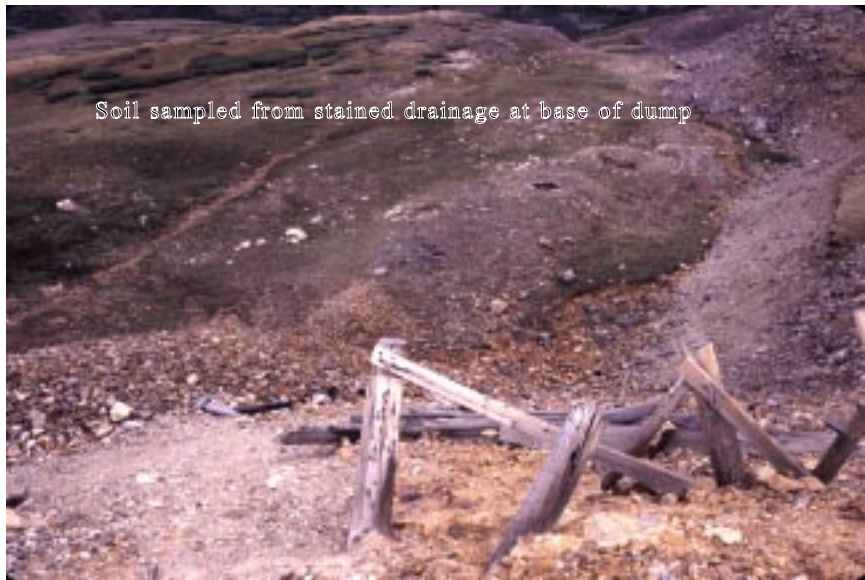
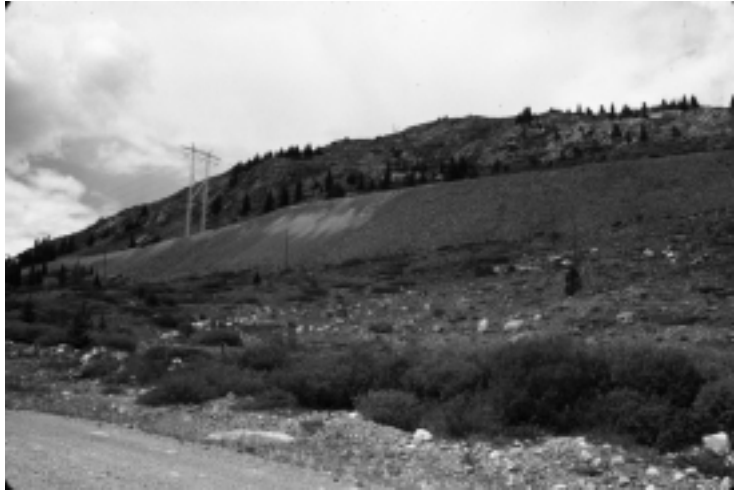
Description and pertinent facts: This inventory site includes the historic North London Mine and Mill. The Mill and tailing ponds reside entirely on patented lands. No impact to Buckskin Creek was seen. The North London Mine was worked for several years and has extensive underground workings. The mine dump, feature 200, is one of the largest in the Alma area. It is estimated to be 44,000 c.y. Approximately half of the dump is on patented land, the other half on USFS lands. The dump is rich in metal sulfide minerals.

Common yellow-red staining can be seen in the dump material. The bulk of the dump is within a natural drainage to Mosquito Creek, 3500 feet away, down in the valley. The drainage course is heavily stained and filled with fines that have been weathered from the dump by sheet wash. This drainage was dry at the time of the

inspection, August 23, 1994, but it's obvious that drainage occurs from the dump to Mosquito Creek during spring run-off. The drainage course is stained for about 1000 feet below the dump. A soil sample of the heavily stained fines from the gully bottom was taken and analyzed by the Colorado Department of Health Inorganic Chemistry Lab. The analysis results were:

The high levels of copper, iron, lead, and zinc impact aquatic life, specifically native and sport fish. This site was given a rating of 2 (significant environmental degradation) because it is likely that surges of waters with high metal concentrations occur every spring from this drainage into Mosquito Creek when it is flushed by run-off. The dump supplies new fines annually, recharging metal concentrations into the drainage.

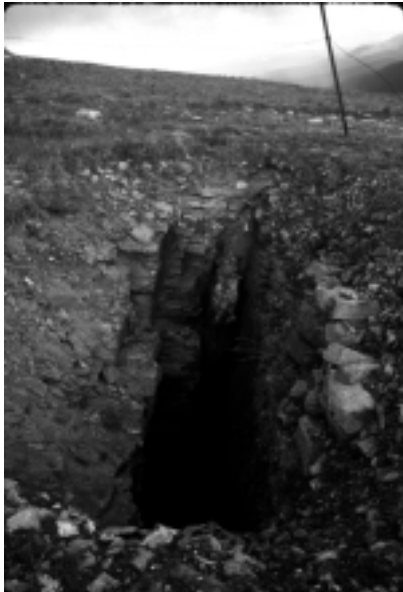
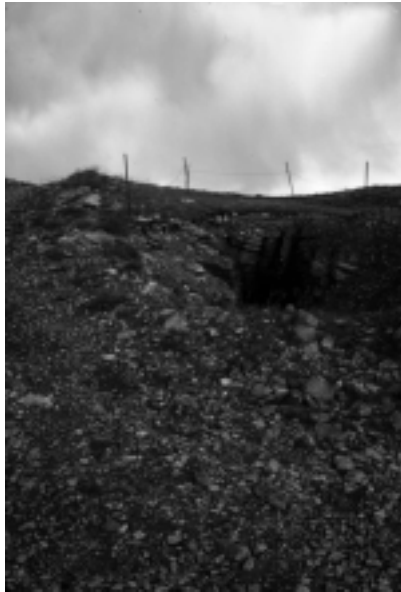
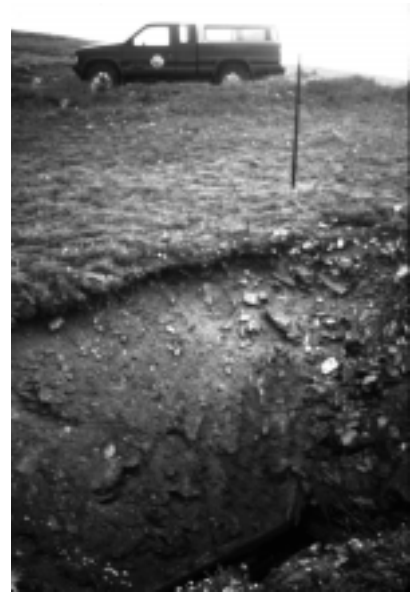
Sites 107, 108, 109 are also open shafts and daylighted stopes(?) and, while on private property, are immediately next to FR 189. Site #108 cratering is beginning to encroach into the edge of the road.

These three sites have single strand barb wire fencing around them but they are deteriorating and the deterrent effect is minimal. These features were given hazard ratings of 1 (extremely dangerous) because of their immediate proximity to the public 4WD road. These sites are narrow enough at the surface that winter snow pack could conceivably bridge across at times creating lethal traps.

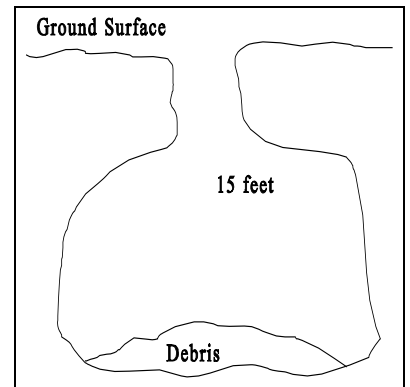
This shaft is particularly dangerous because of its immediate proximity to the mine access road and the morphology of the mine itself. The shaft, while only 15 feet in depth opens to a mined out area with horizontal headings that has left a "room" with the shaft in the middle. The surface near the shaft collar is now undermined and is susceptible to collapse into the hole. See figure.
